From: "Davis, Mike" <MDavis@archcoal.com>
To: "Carter Reed (E-mail)" <creed01@fs.fed.us>, "Chris Hansen (E-mail)" <CHansen@archcoal.com>, "Craig Hilton (E-mail)" <CHilton@archcoal.com>, "Dana Dean" <danadean@utah.gov>, "Daron Haddock (E-mail)" <daronhaddock@utah.gov>, "Dave Darby (E-mail)" <davedarby@utah.gov>, "Erik Petersen (E-mail)" <petersen@relia.net>, "Jerriann Ernstsens (E-mail)" <jerriannernstsens@utah.gov>, "Ken May (E-mail)" <KMay@archcoal.com>, "Mark Bunnell (E-mail)" <MBunnell@archcoal.com>, "Pam Grubaugh-Littig (E-mail)" <Pamgrubaughlittig@utah.gov>, "Pete Hess (E-mail)" <petehess@utah.gov>, "Stan Perkes" <sperkes@blm.gov>, "Steve Fluke (E-mail)" <stevefluke@utah.gov>, "Susan White (E-mail)" <susanwhite@utah.gov>, "Tom Lloyd" <twlloyd@fs.fed.us>
Date: 5/4/04 8:01AM
Subject: East Fork Box Canyon Monitoring Data April 29, 2004

East Fork Box Canyon

Field Notes: 29 Apr 2004

EAST FORK OF BOX CANYON WEEKLY MONITORING

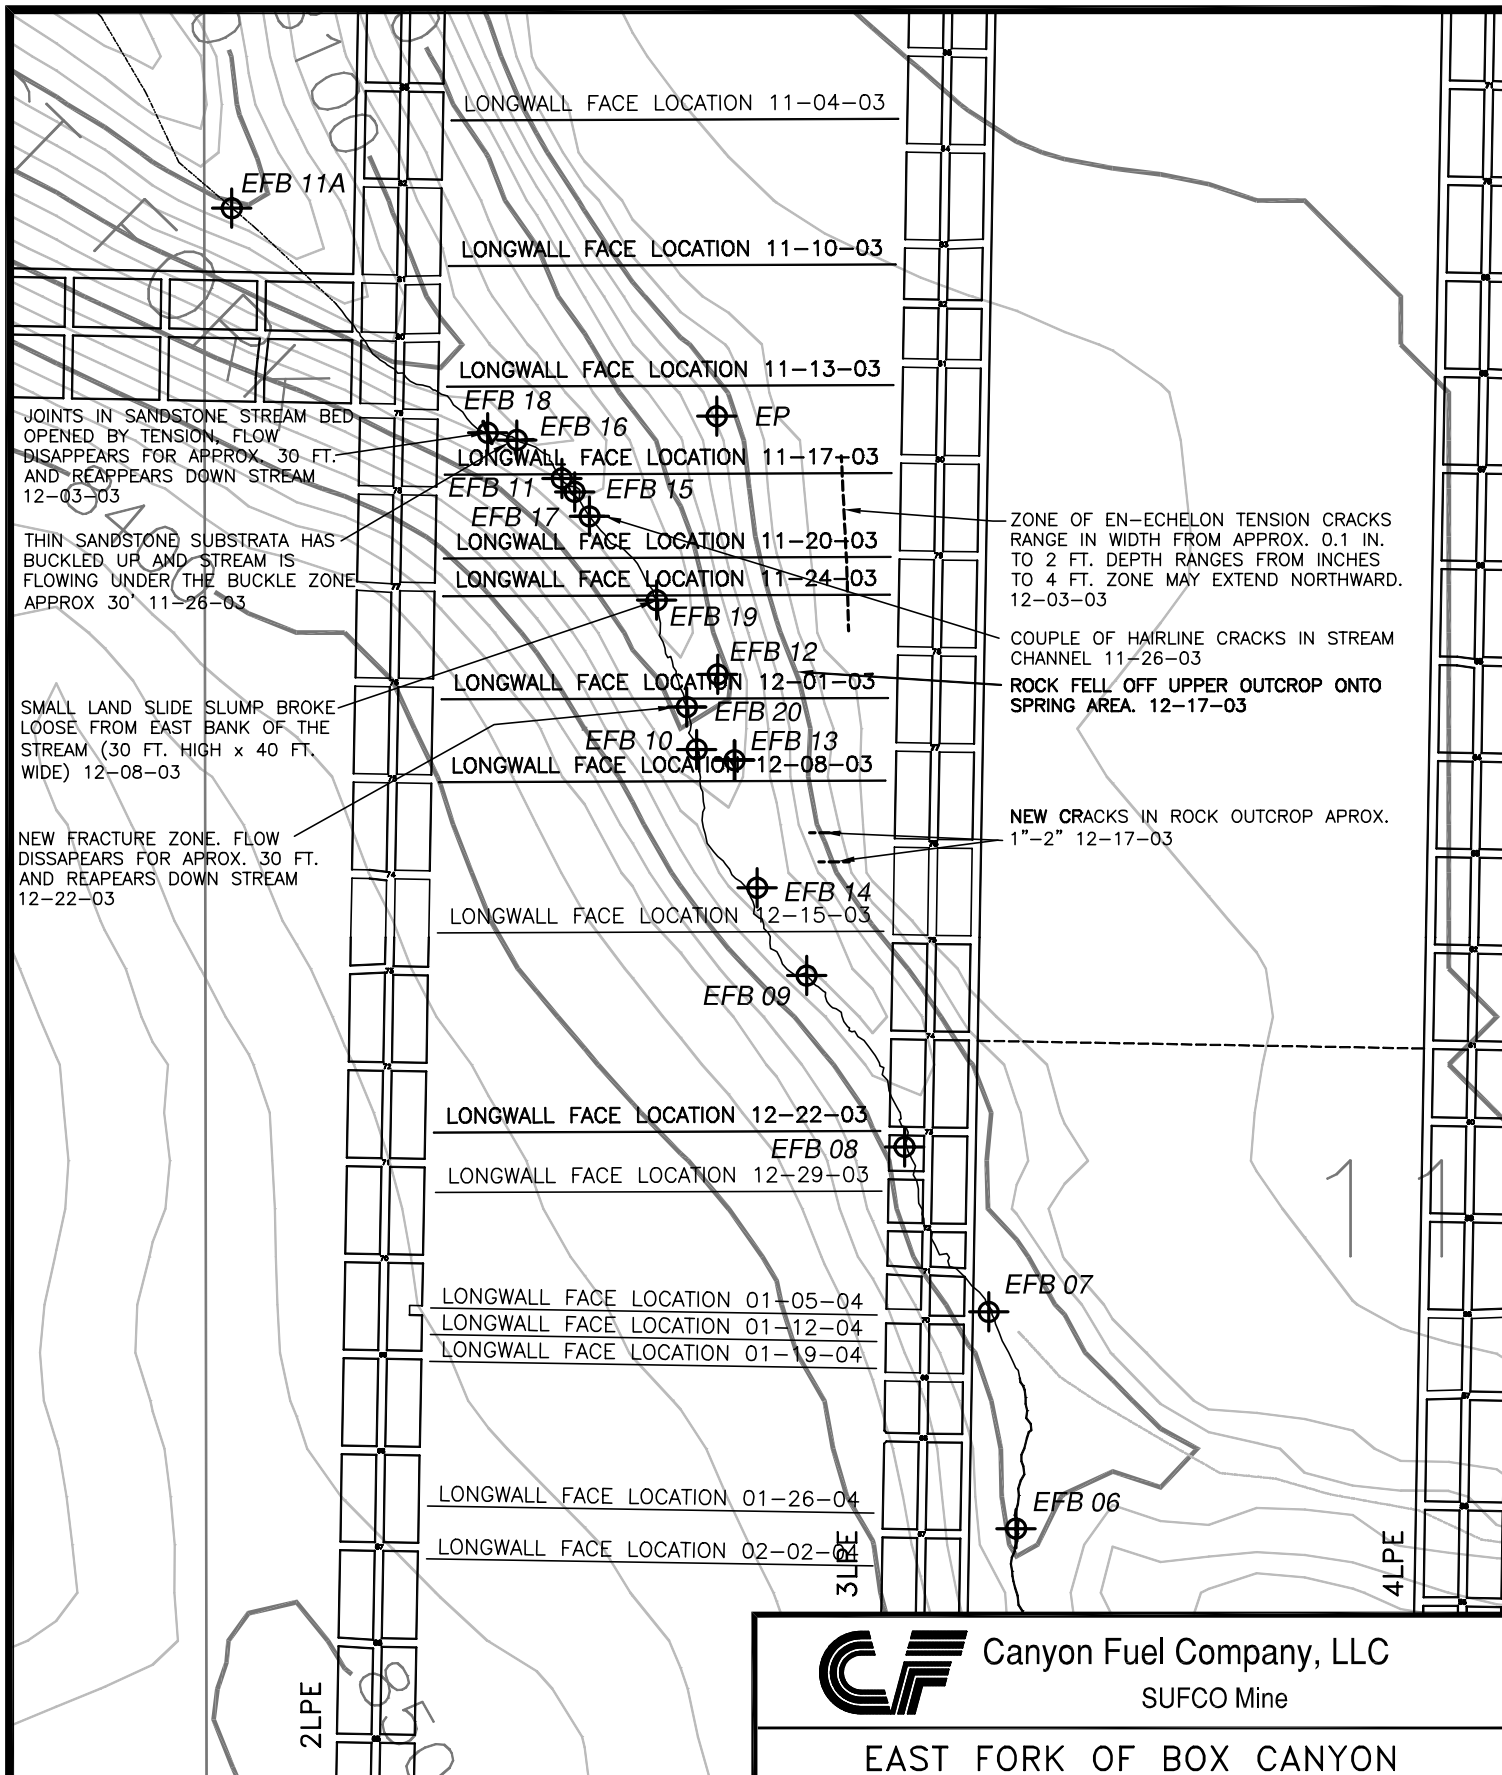
Observed a new fracture zone in the stream channel located approximately 100 feet above EFB-10. The fractures occur in thin-bedded silty sandstone in the channel bottom. All of the stream flow infiltrated into the fracture system at that point. The stream channel was dry for approximately 150-200 feet. At that point the water reemerged into the stream channel. Because this reach of the stream was buried under snow during previous monitoring events, the fractures and stream infiltration could possibly be an old occurrence that happened back in late December or early January and went unobserved.

The map will need to be updated later to include the new stream segment where flow infiltrates into the fracture area between EFB-10 and EFB-14 since our draftsman is off this week.
